**A post-evaluation of rainfall reports associated with
the Pawnee Creek flood of July 29-30, 1997 in
eastern Weld and western Logan counties
in northeast Colorado**

Colorado Climate Center
Department of Atmospheric Science
Colorado State University
Fort Collins, CO 80523-1371
(970) 491-8545

August 1998

Climatology Report No. 98-3

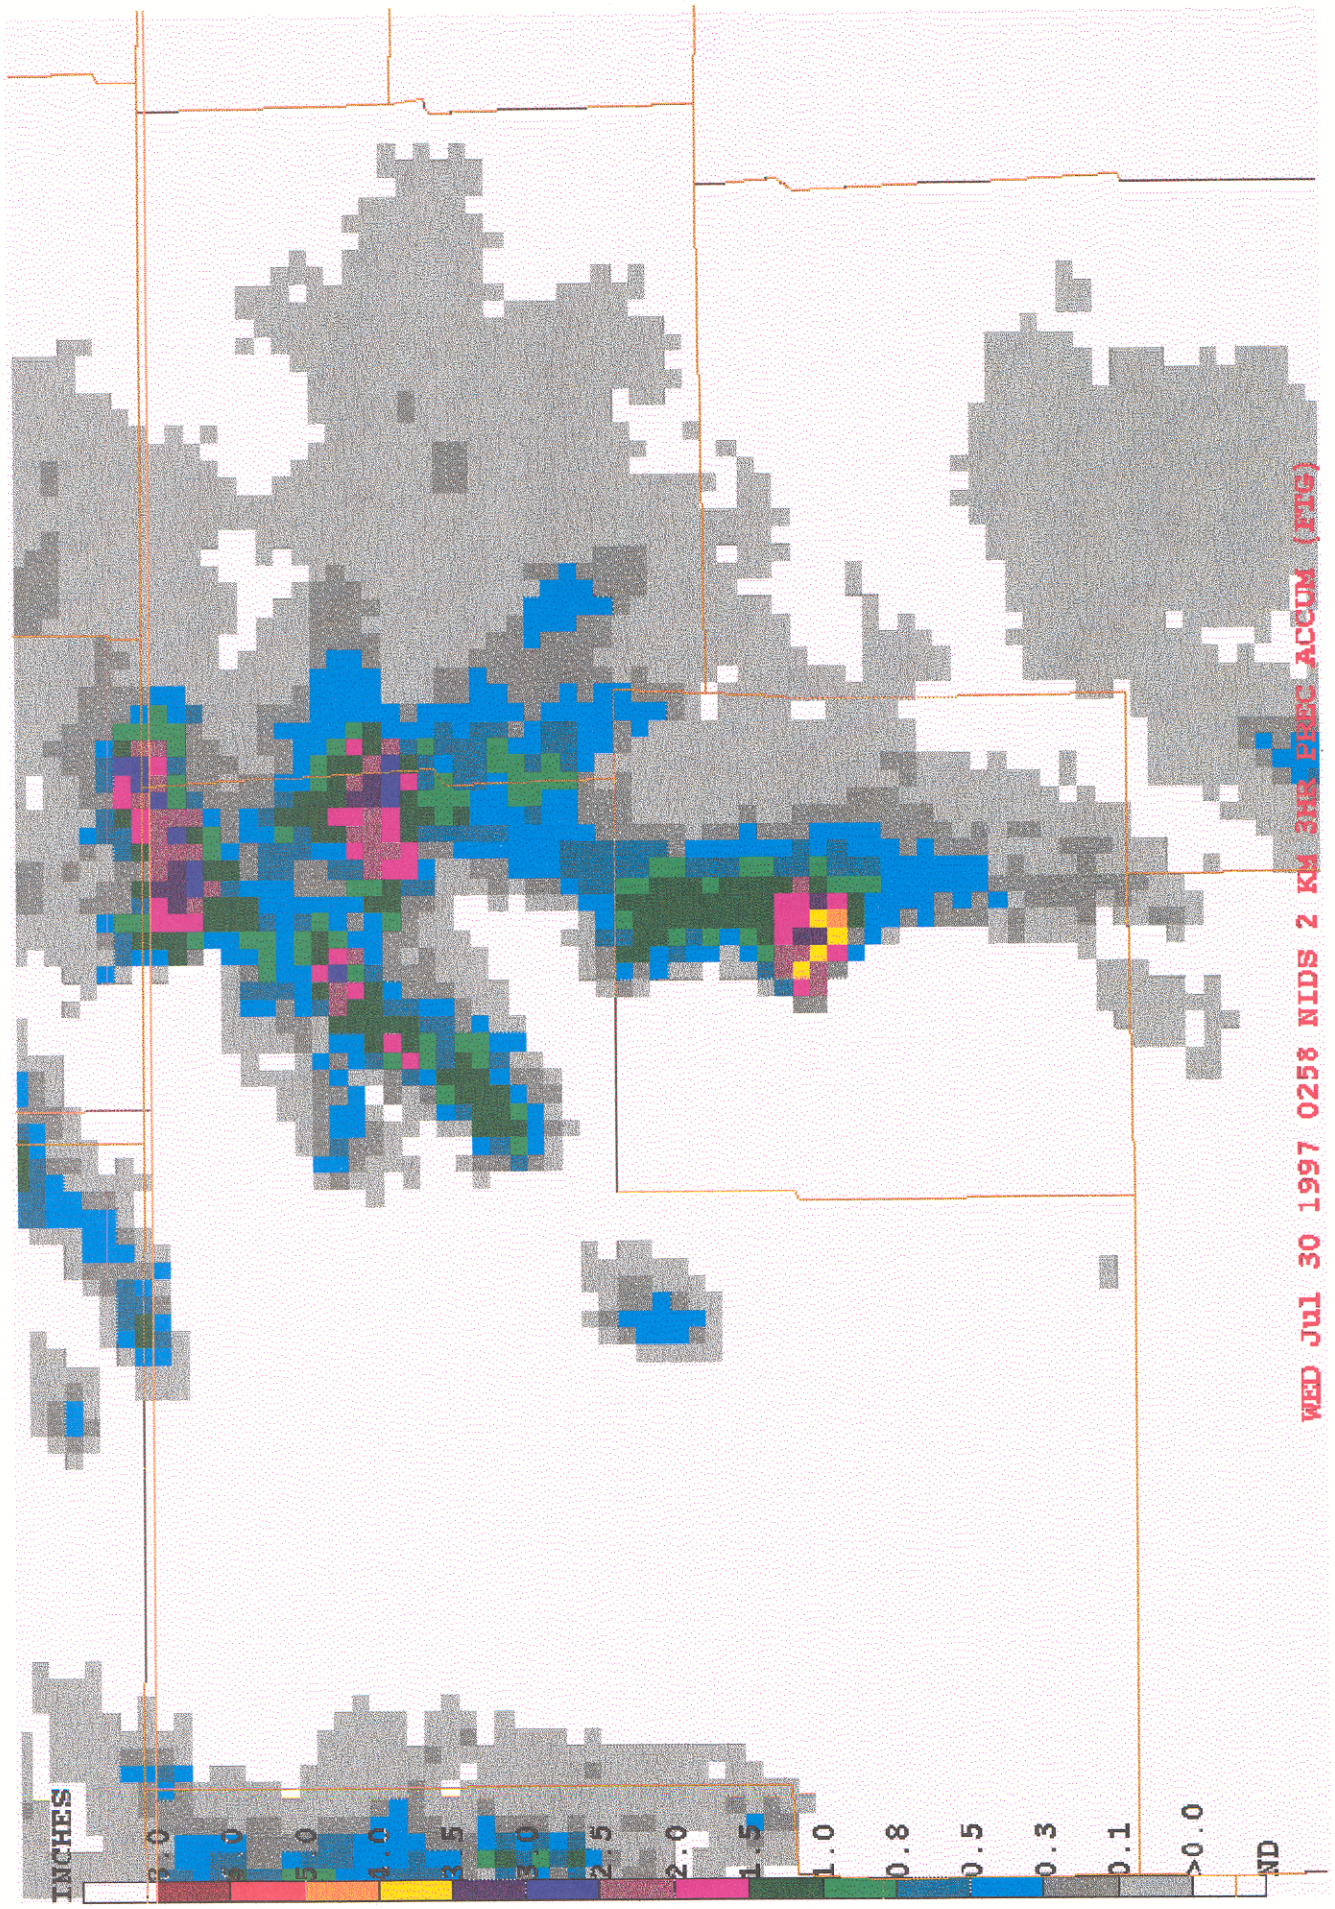
Figure 1.

Four maps are included in this report to show the general spatial patterns and timing of rainfall as estimated by radar for successive three-hour period. Keep in mind that some heavy rain had already fallen in extreme northeastern Weld County and adjacent areas during the afternoon of the 29th, and this is not included on the maps provided here. Readers should please be aware that radar is an excellent tool for tracking storms, defining storm areas, motions and relative intensities. However, the technology is not always capable of accurately determining the rainfall that reaches the ground. Therefore, the results below need to be interpreted carefully with that limitation in mind.

There are many interesting features of the storms shown by these radar products. For example, a narrow band of very heavy precipitation can be seen extending southwestward from the center of maximum rainfall to a point west of New Raymer. Another feature is the secondary rainfall maximum that appears over extreme northeast Weld County. Heavy rains also fell that night over Morgan County but were not the focus of this study.

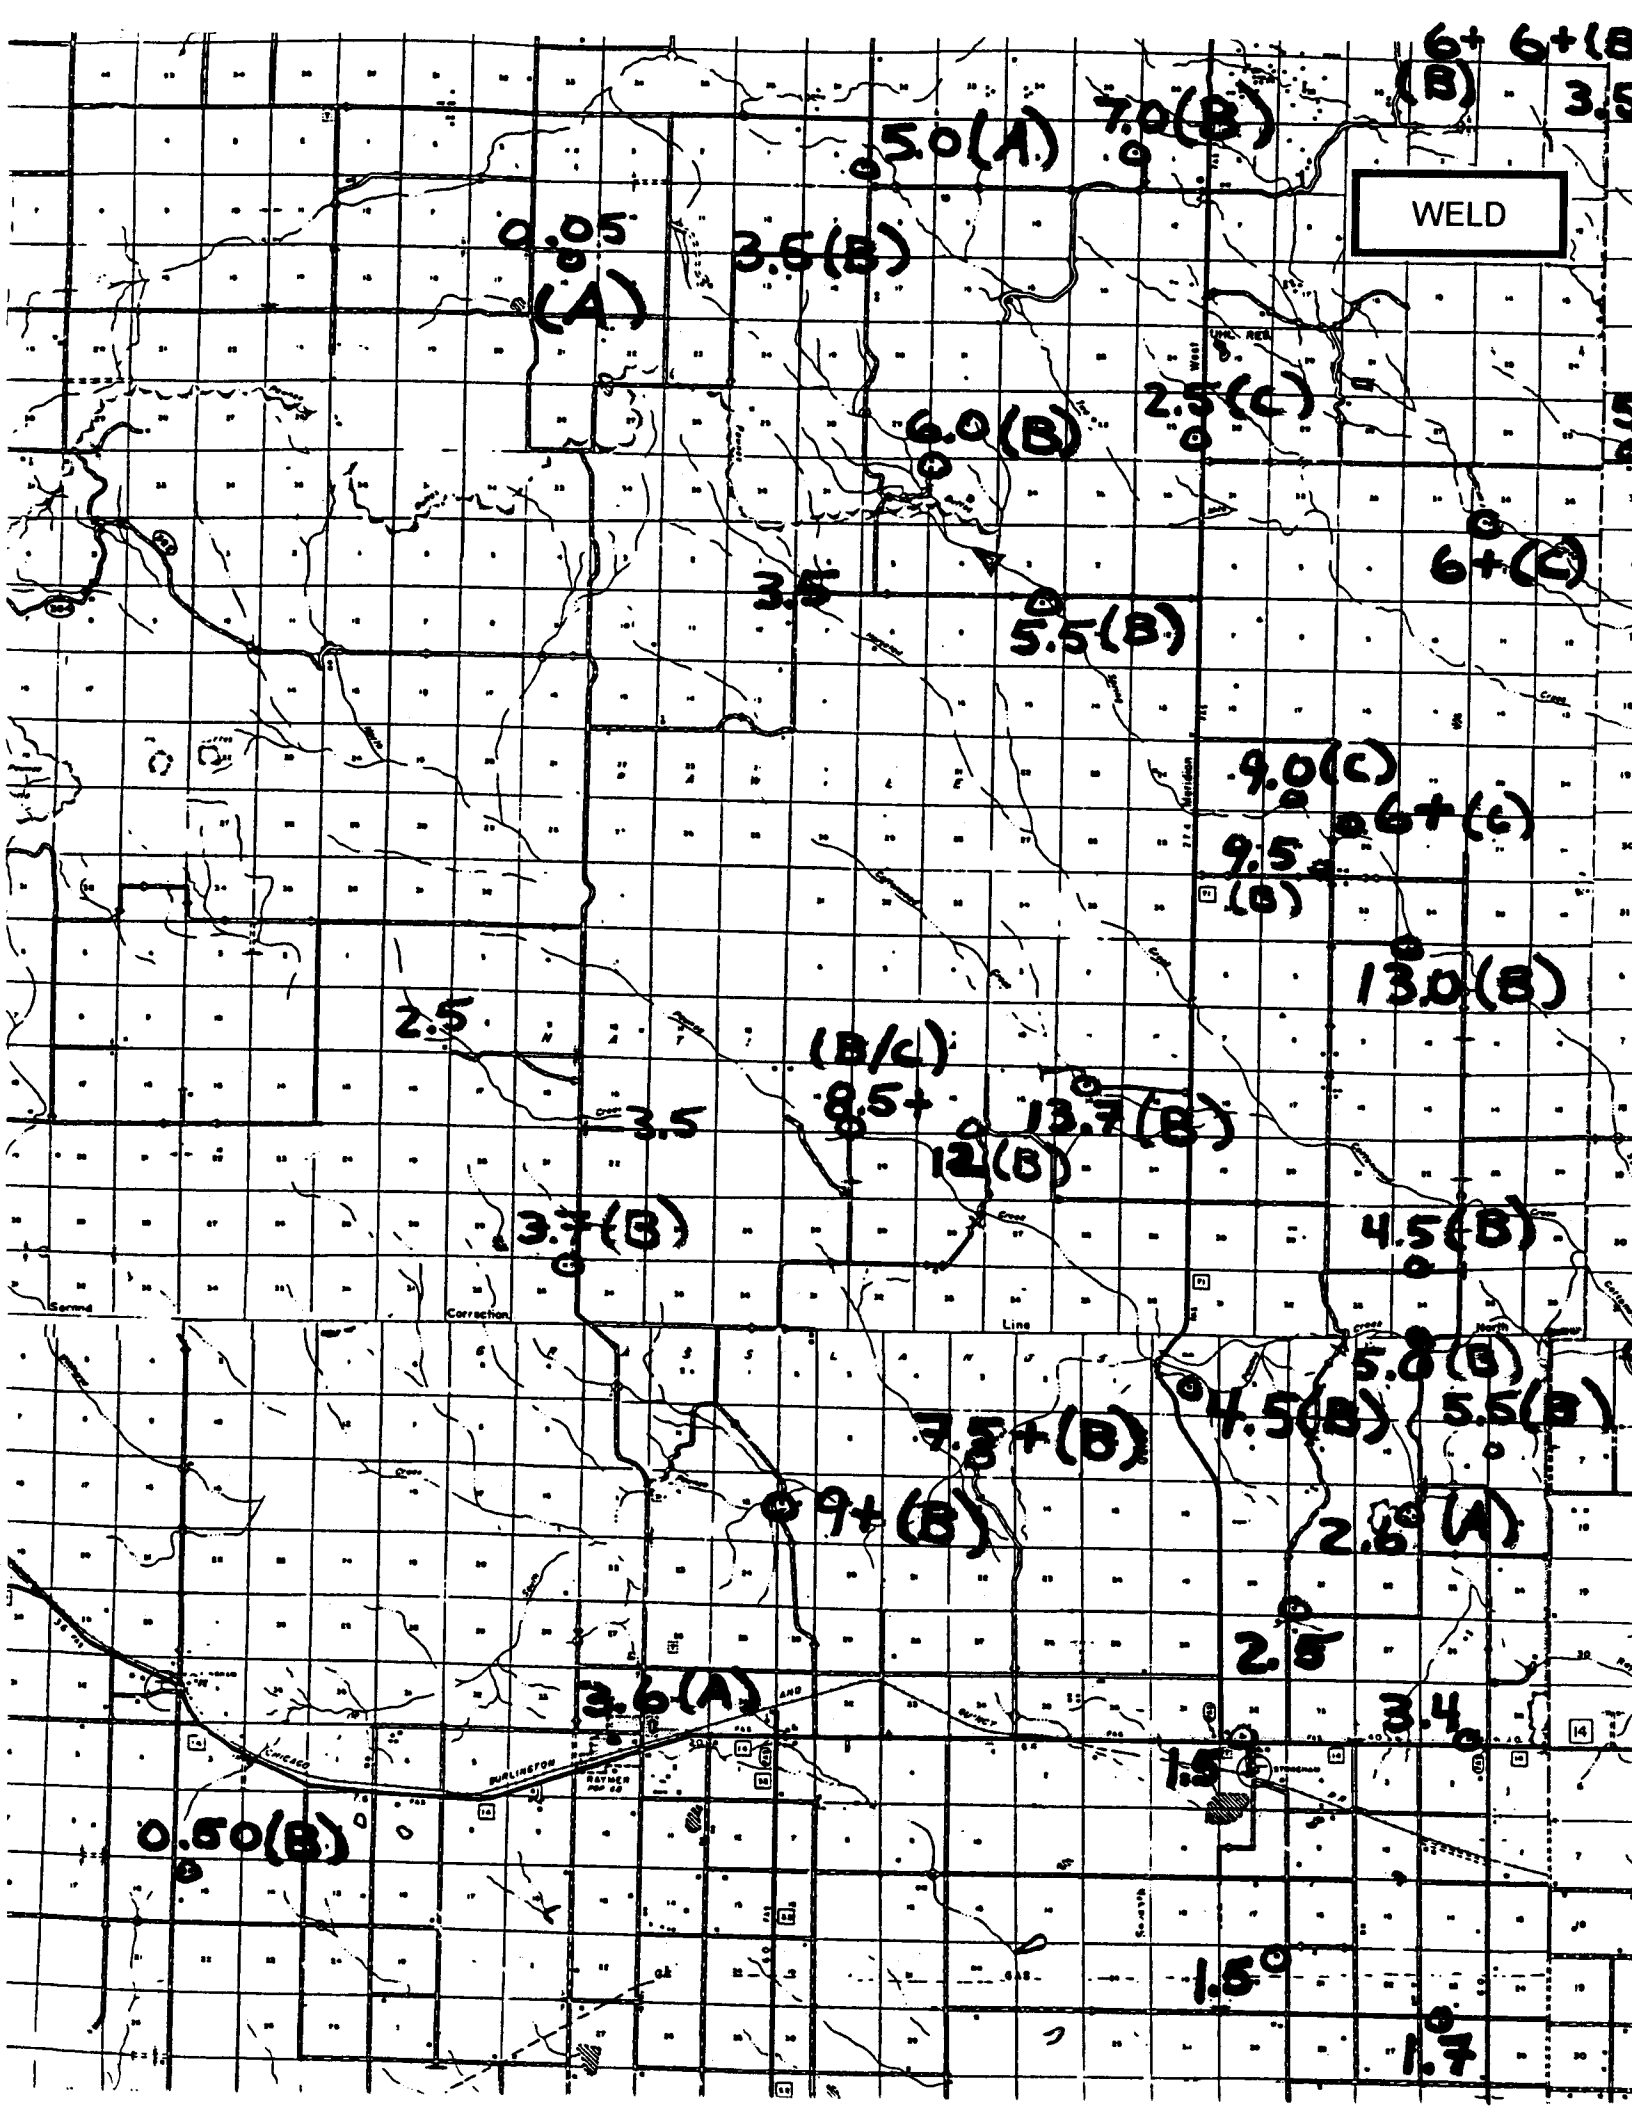
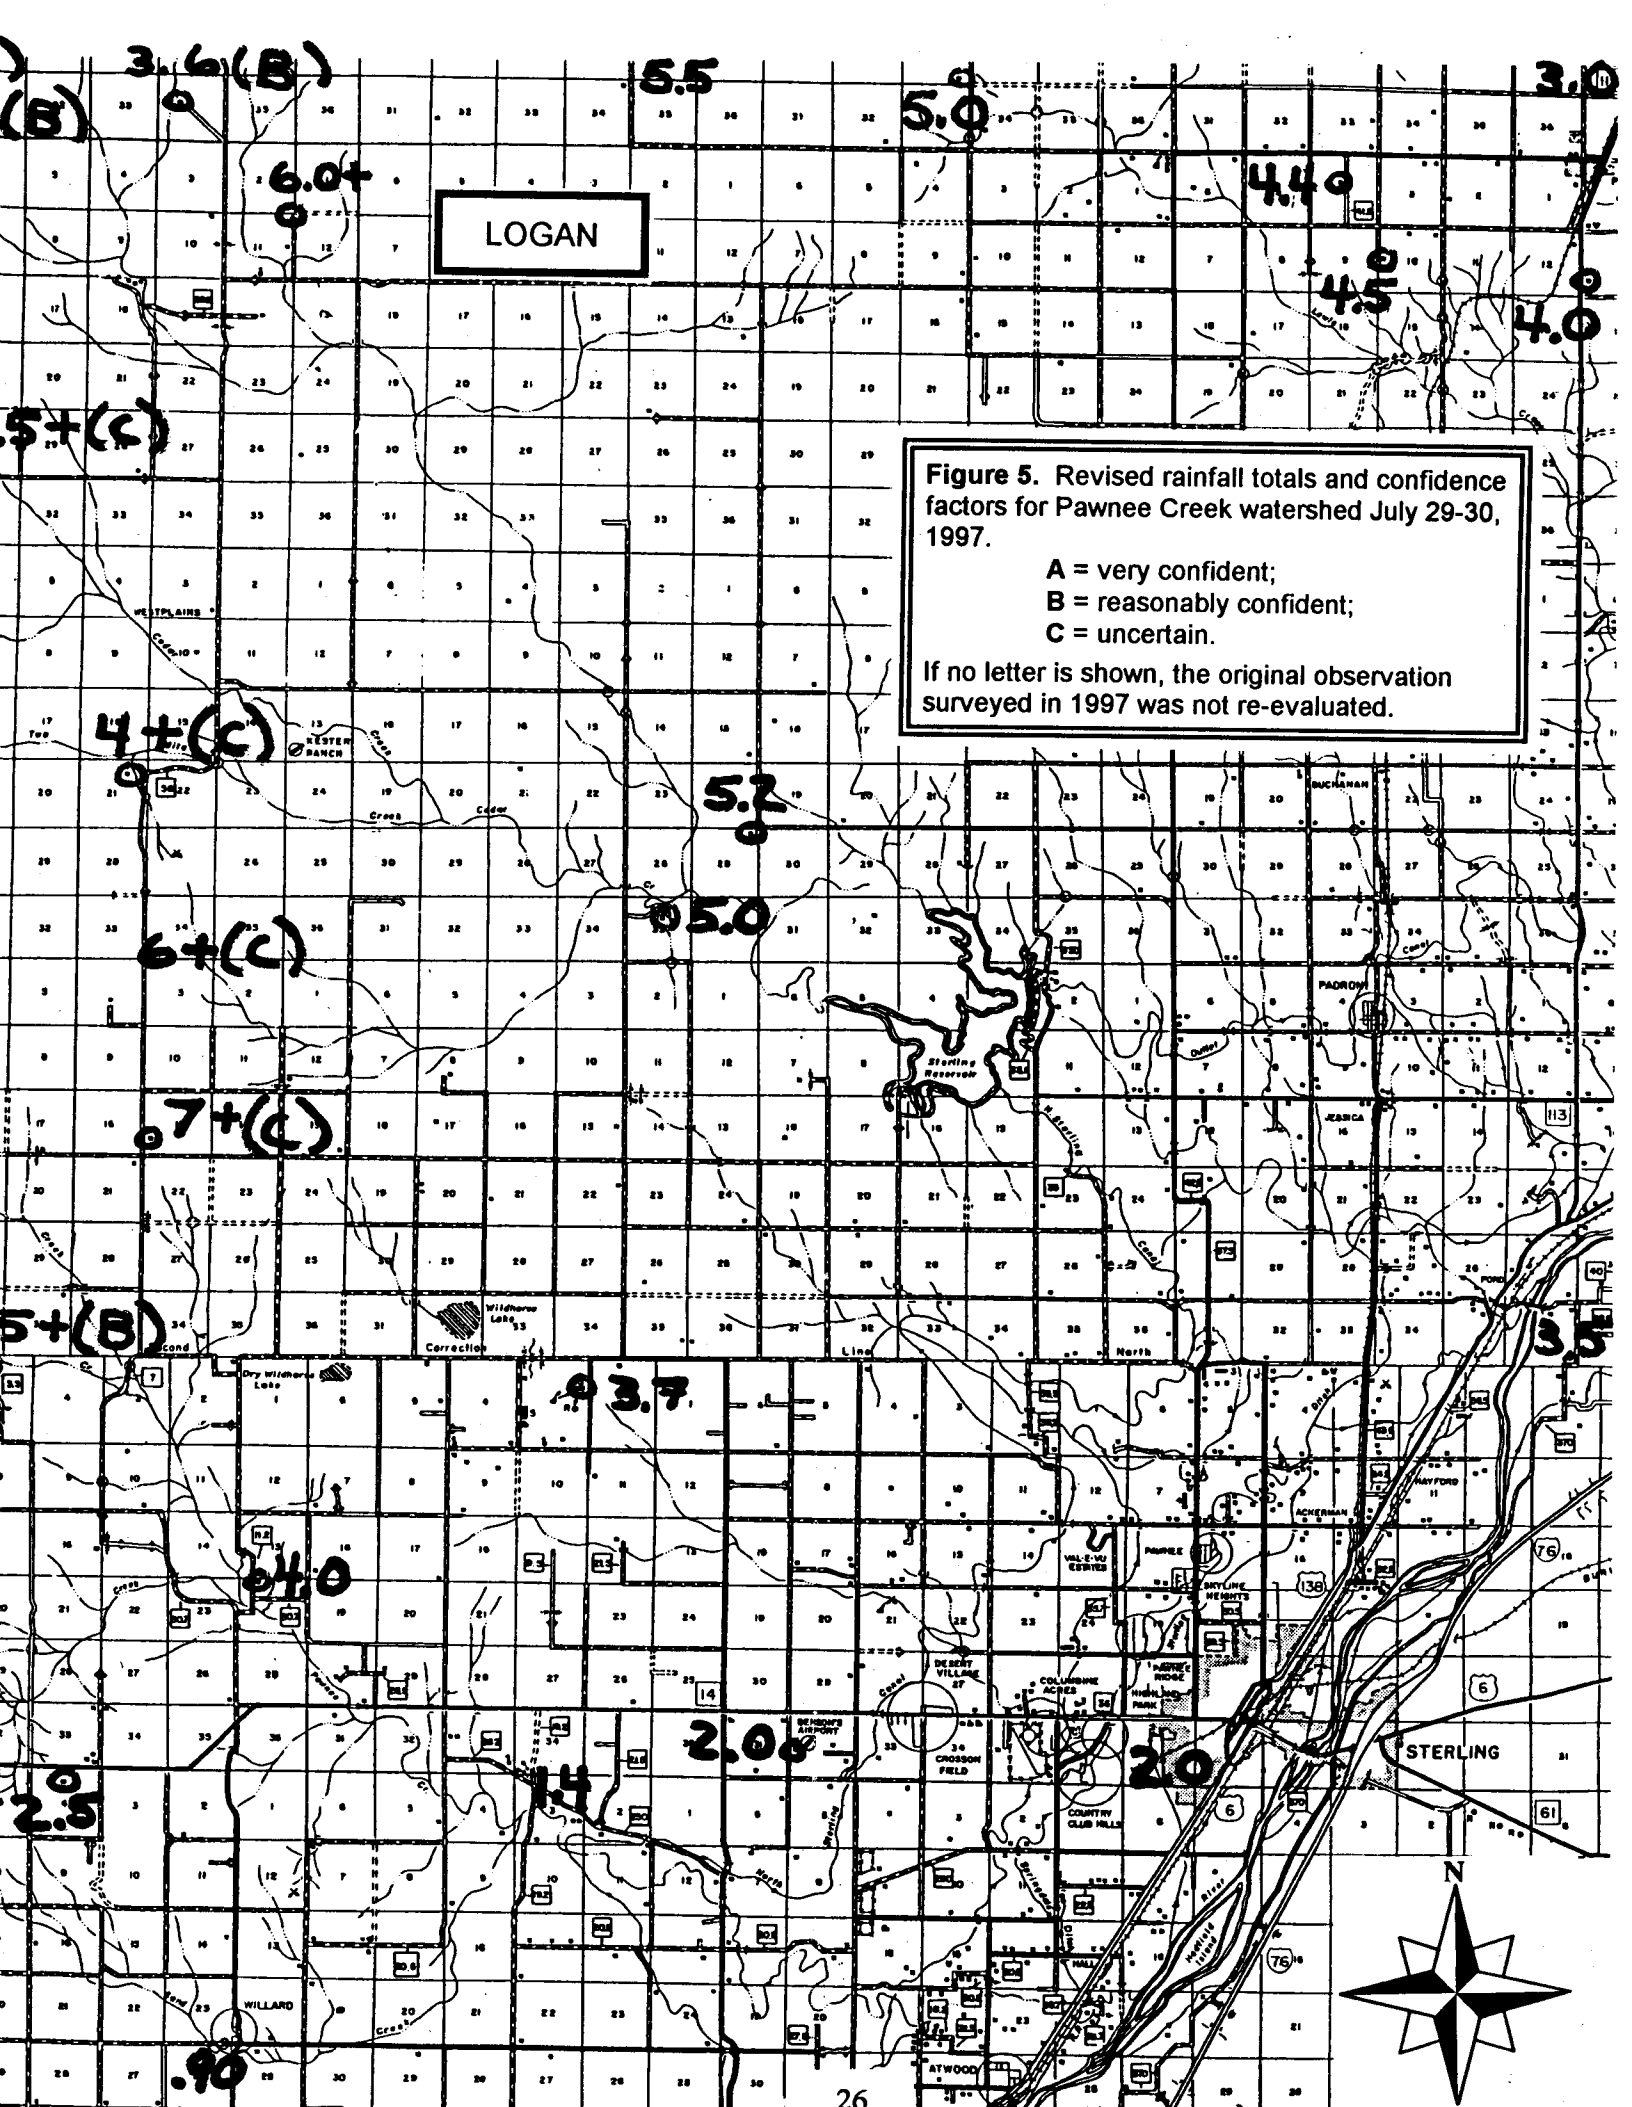
Figure 5. Revised rainfall totals and confidence factors for Pawnee Creek watershed July 29-30, 1997.

A = very confident;
 B = reasonably confident;
 C = uncertain.

A map of point rainfall reports was produced (Figure 5). Keep in mind that only those reports in Weld County and extreme western Logan County were reviewed during this survey. By comparing this to the results of the original storm survey and draft document of October 1997, some differences in rainfall values are apparent. For example, a few inconsistencies were found in reported rainfall amounts between the data tabulation prepared by the CWCB in 1997 and the rainfall totals plotted on preliminary rainfall maps. We are choosing in favor of the values reported to us this year, if different from what was noted last year and if evidence suggests that the entries made last year were inaccurate. There were also a few inaccuracies in station location, and some rainfall reports gathered last year that could not be confirmed in this post evaluation. Most changes, however, are

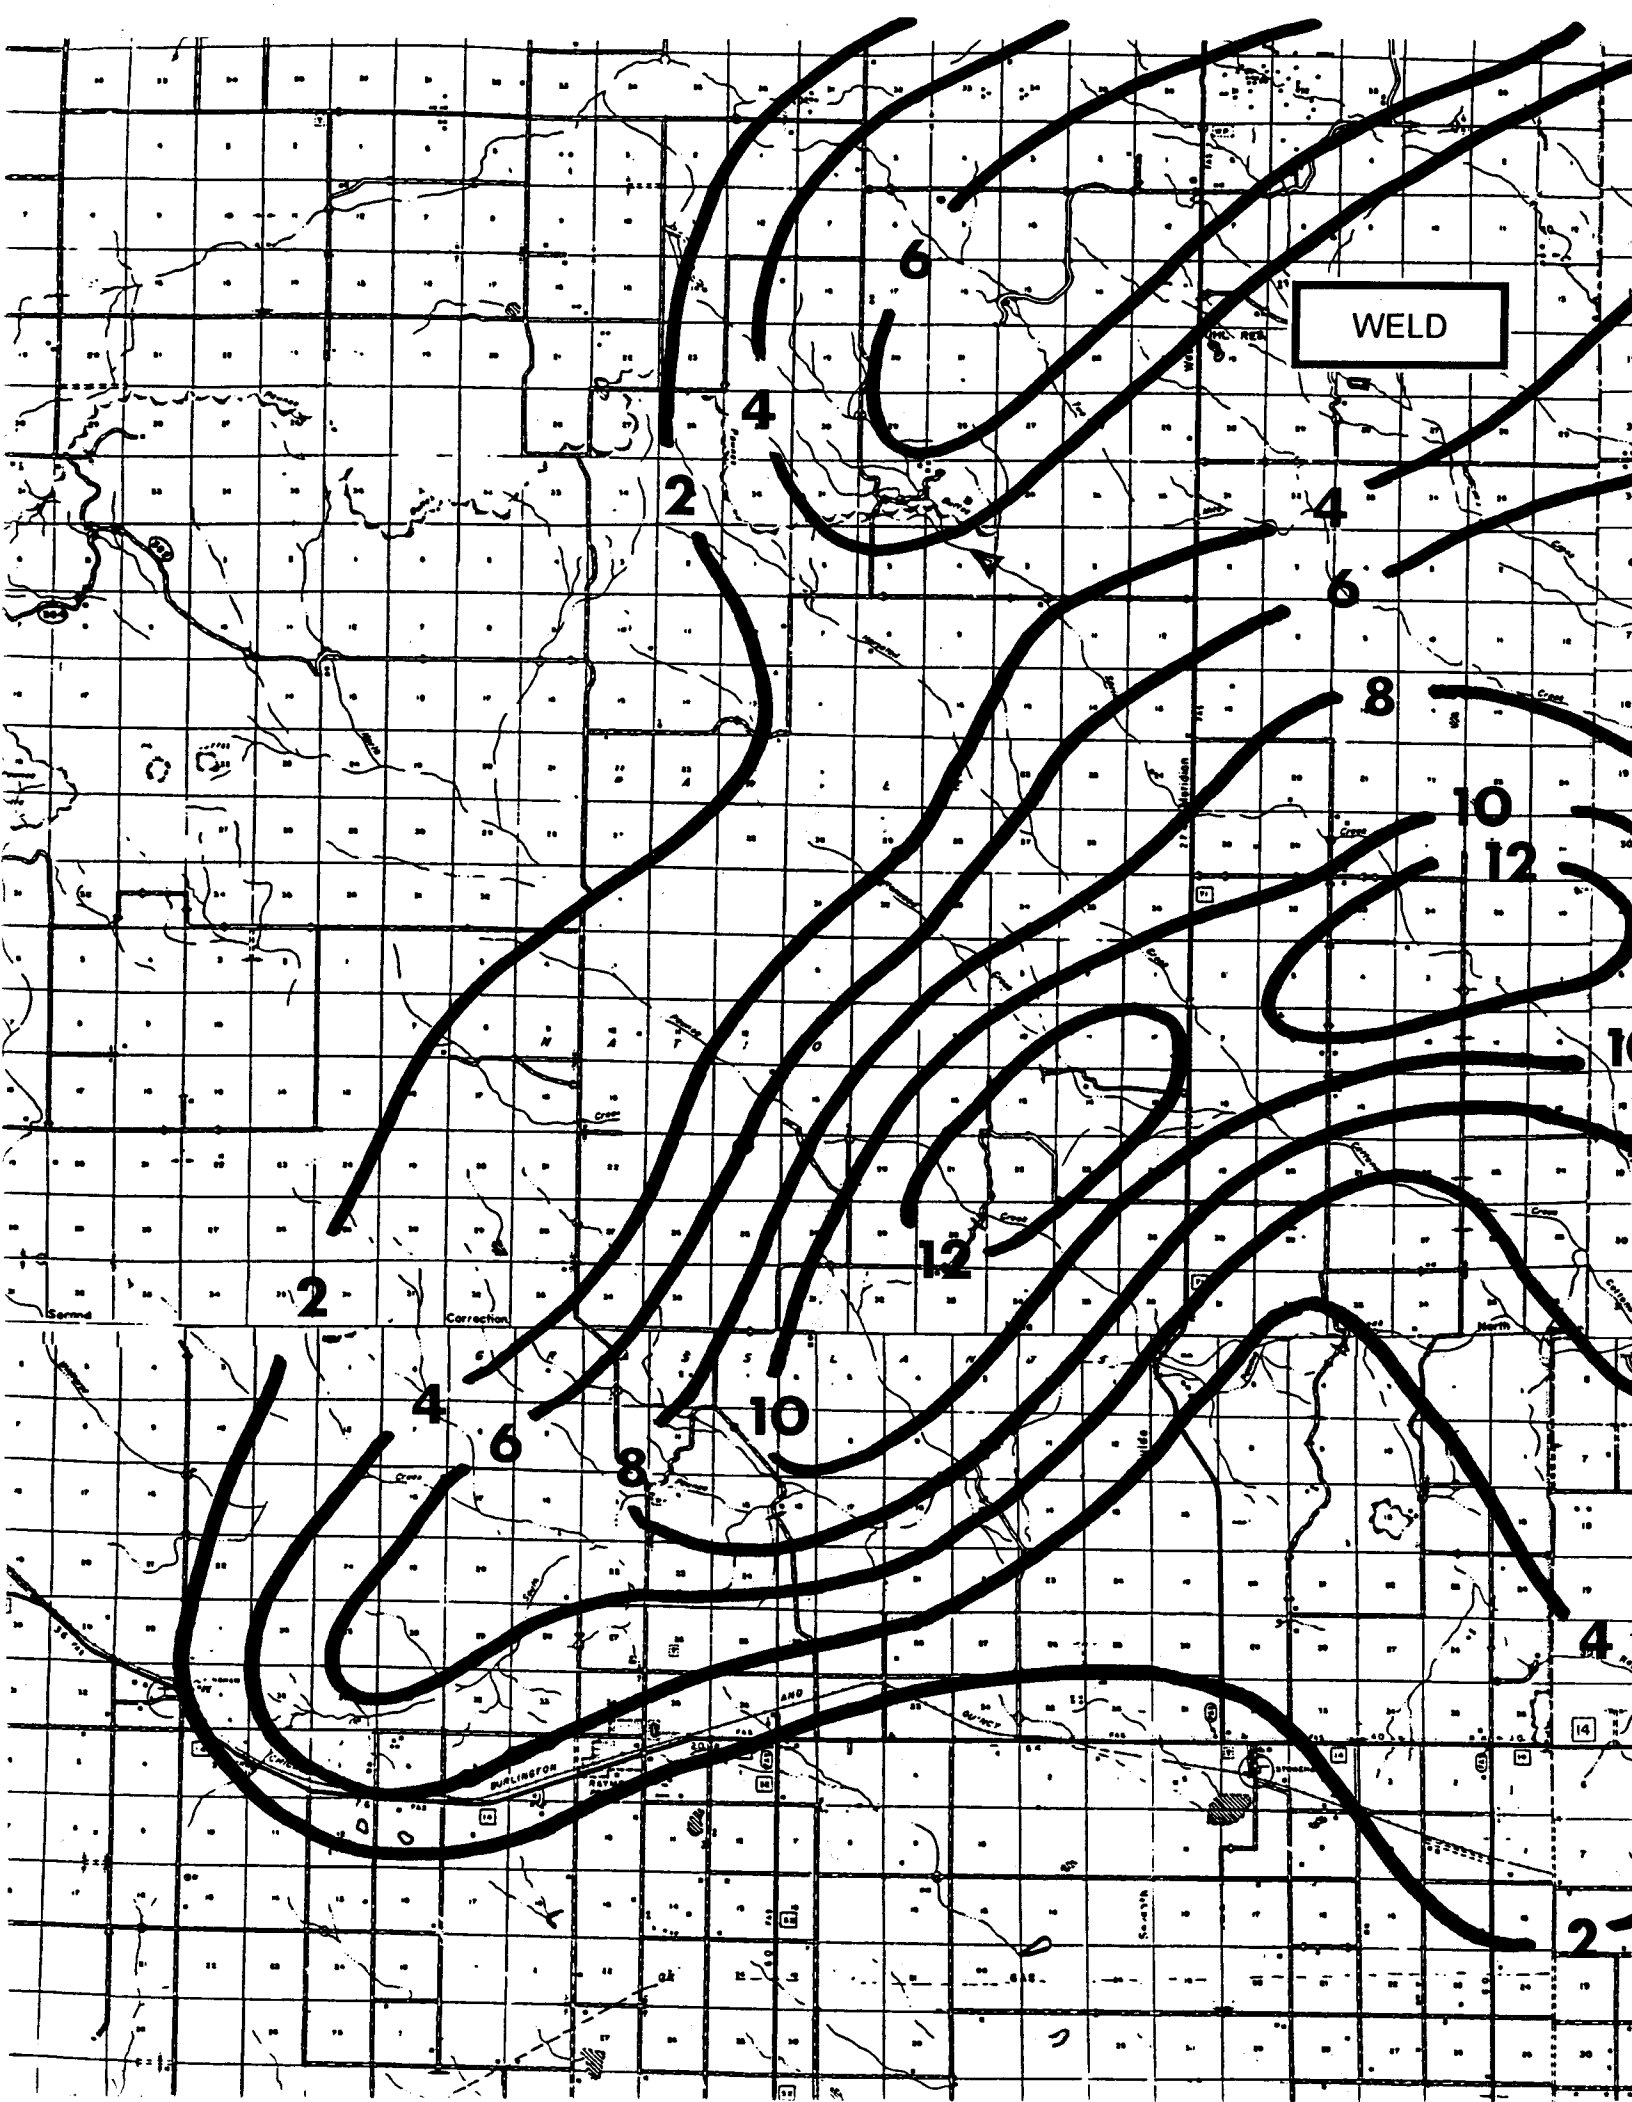
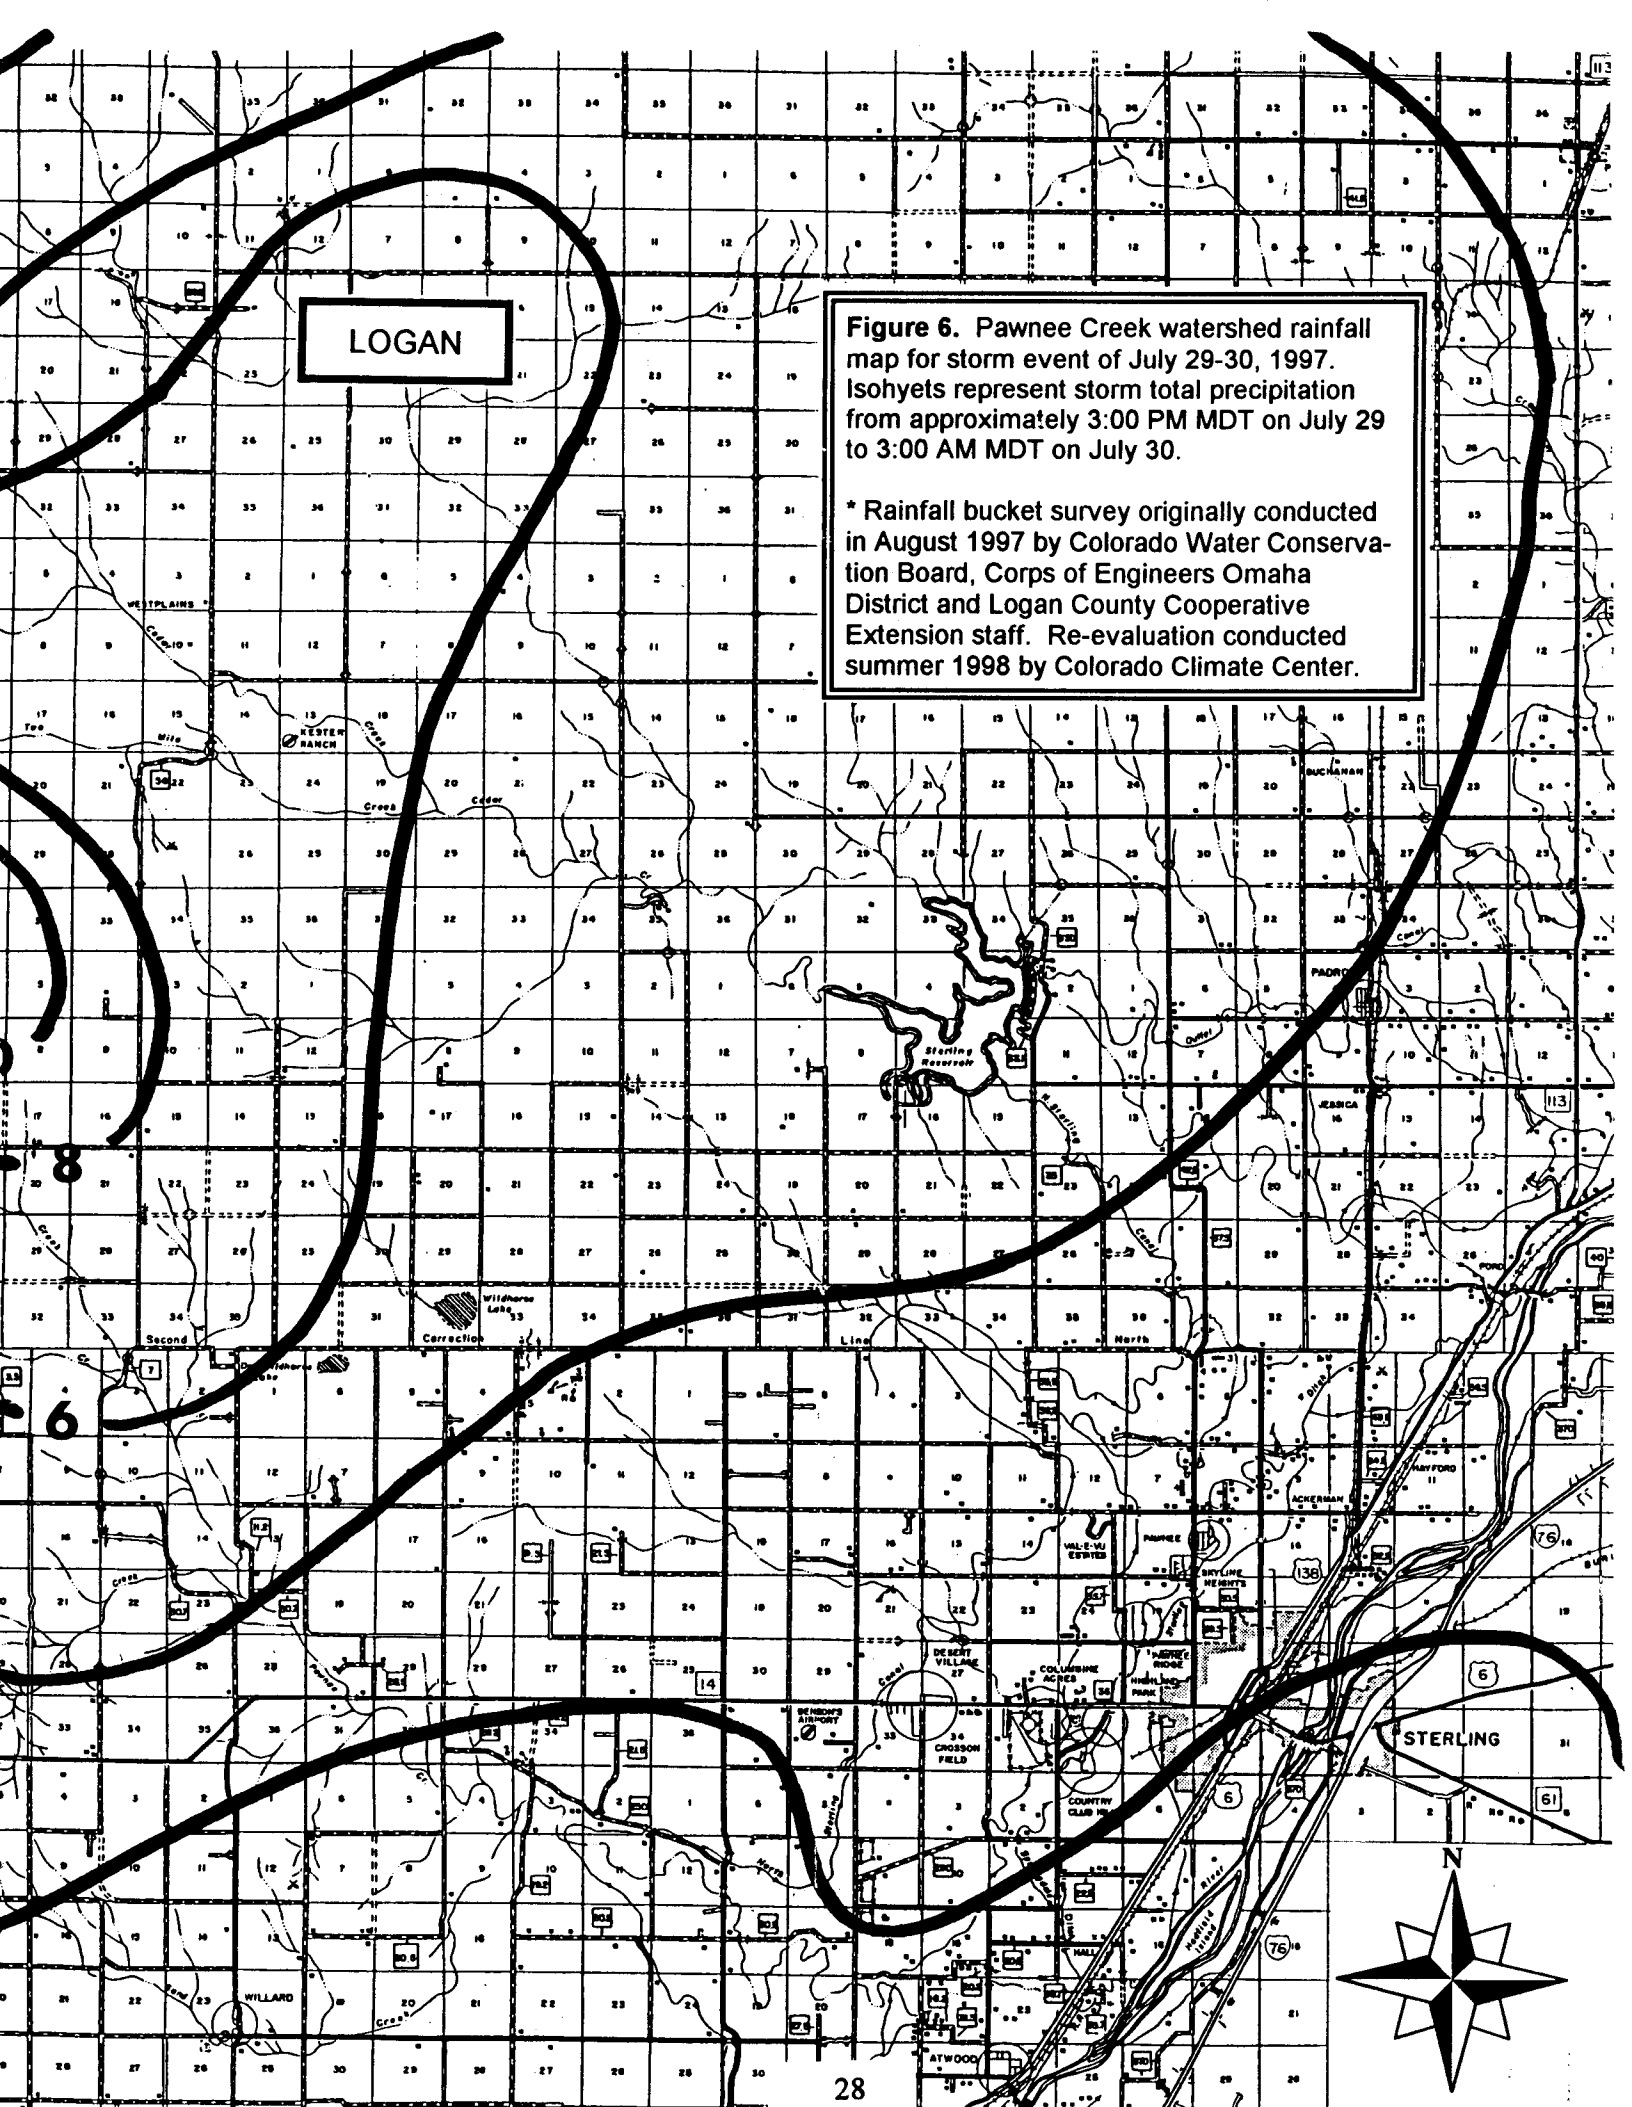
Figure 6. Pawnee Creek watershed rainfall map for storm event of July 29-30, 1997. Isohyets represent storm total precipitation from approximately 3:00 PM MDT on July 29 to 3:00 AM MDT on July 30.

A secondary smaller maximum over northeast Weld County was confirmed but not to the magnitude originally shown (14 inches). Quantitative data only support an estimated maximum at this secondary center of less than ten inches. From interviews with local residents, it appears that this secondary maximum was a result of heavy rain earlier in the afternoon of the 29th that may have begun as early as 3:00 PM MDT far before rain began farther to the south. The rains later in the evening were substantial in that area, but much less than what was observed farther south.

While our re-analysis of the area and magnitude of heaviest rainfall resulted in a reduction of the areas and the magnitude of the most extreme (12 inches and greater) values, the inclusion of additional reports, plus the follow-up with many of the people surveyed last year whose rain gauges may have been full to the top after the storm, suggests that the areas that received more than six inches of rain from the storm may, in fact, be more extensive than originally thought over portions of Weld County and western Logan county. From this analysis, the area receiving at least six inches of rainfall encompassed approximately 270 square miles. This is a very large storm of this magnitude for Colorado.
