**A post-evaluation of rainfall reports associated with
the Pawnee Creek flood of July 29-30, 1997 in
eastern Weld and western Logan counties
in northeast Colorado**

Colorado Climate Center
Department of Atmospheric Science
Colorado State University
Fort Collins, CO 80523-1371
(970) 491-8545

August 1998

Climatology Report No. 98-3

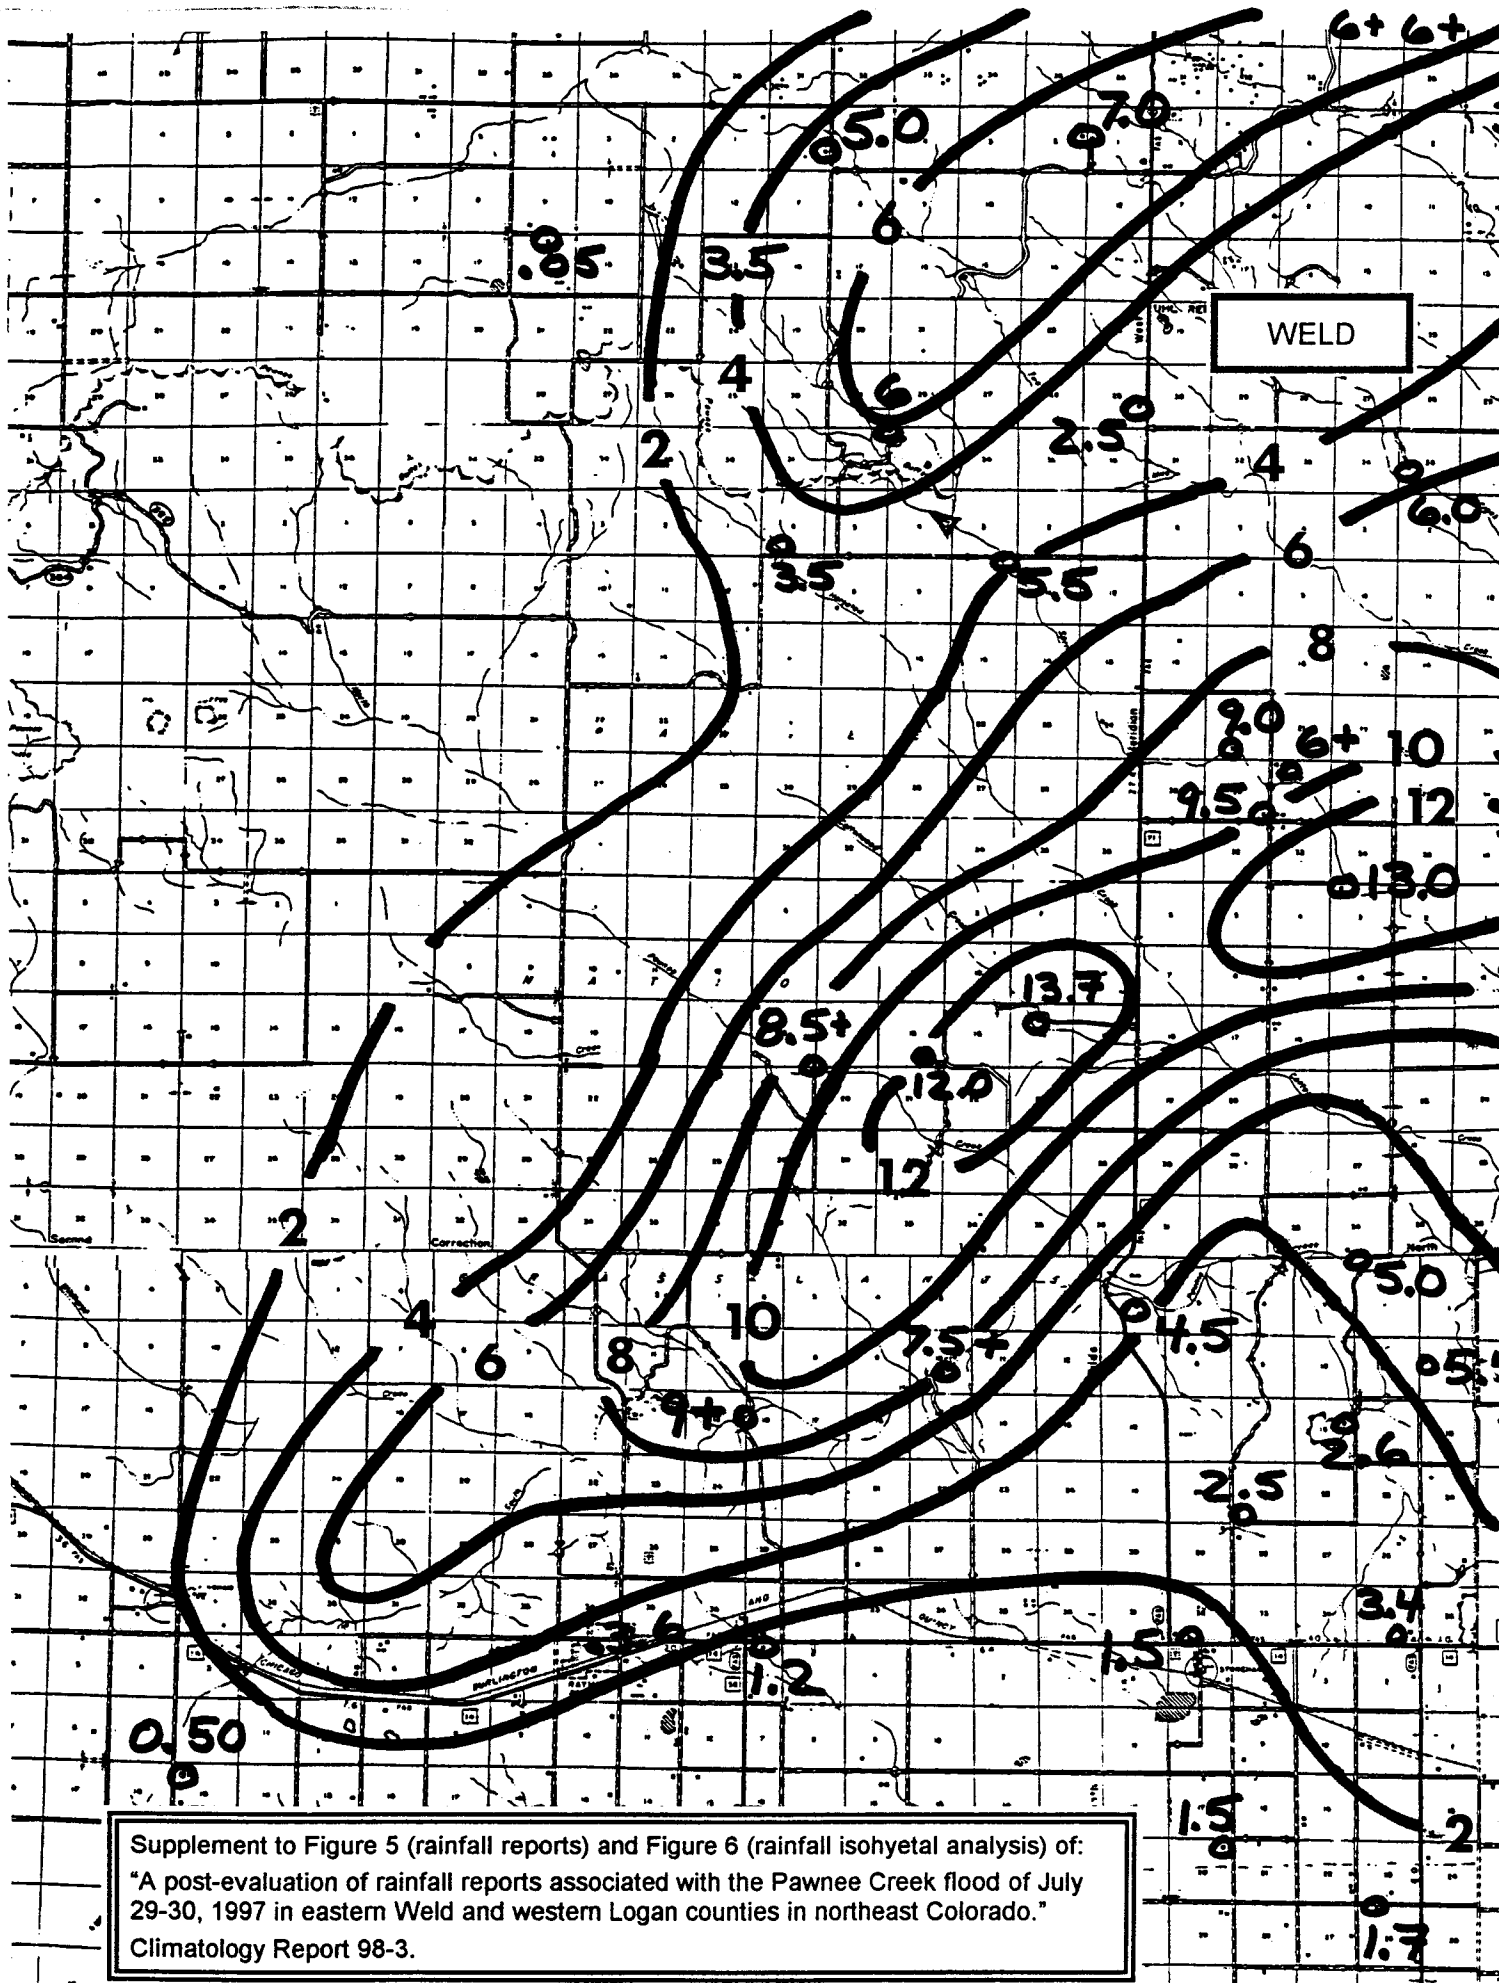
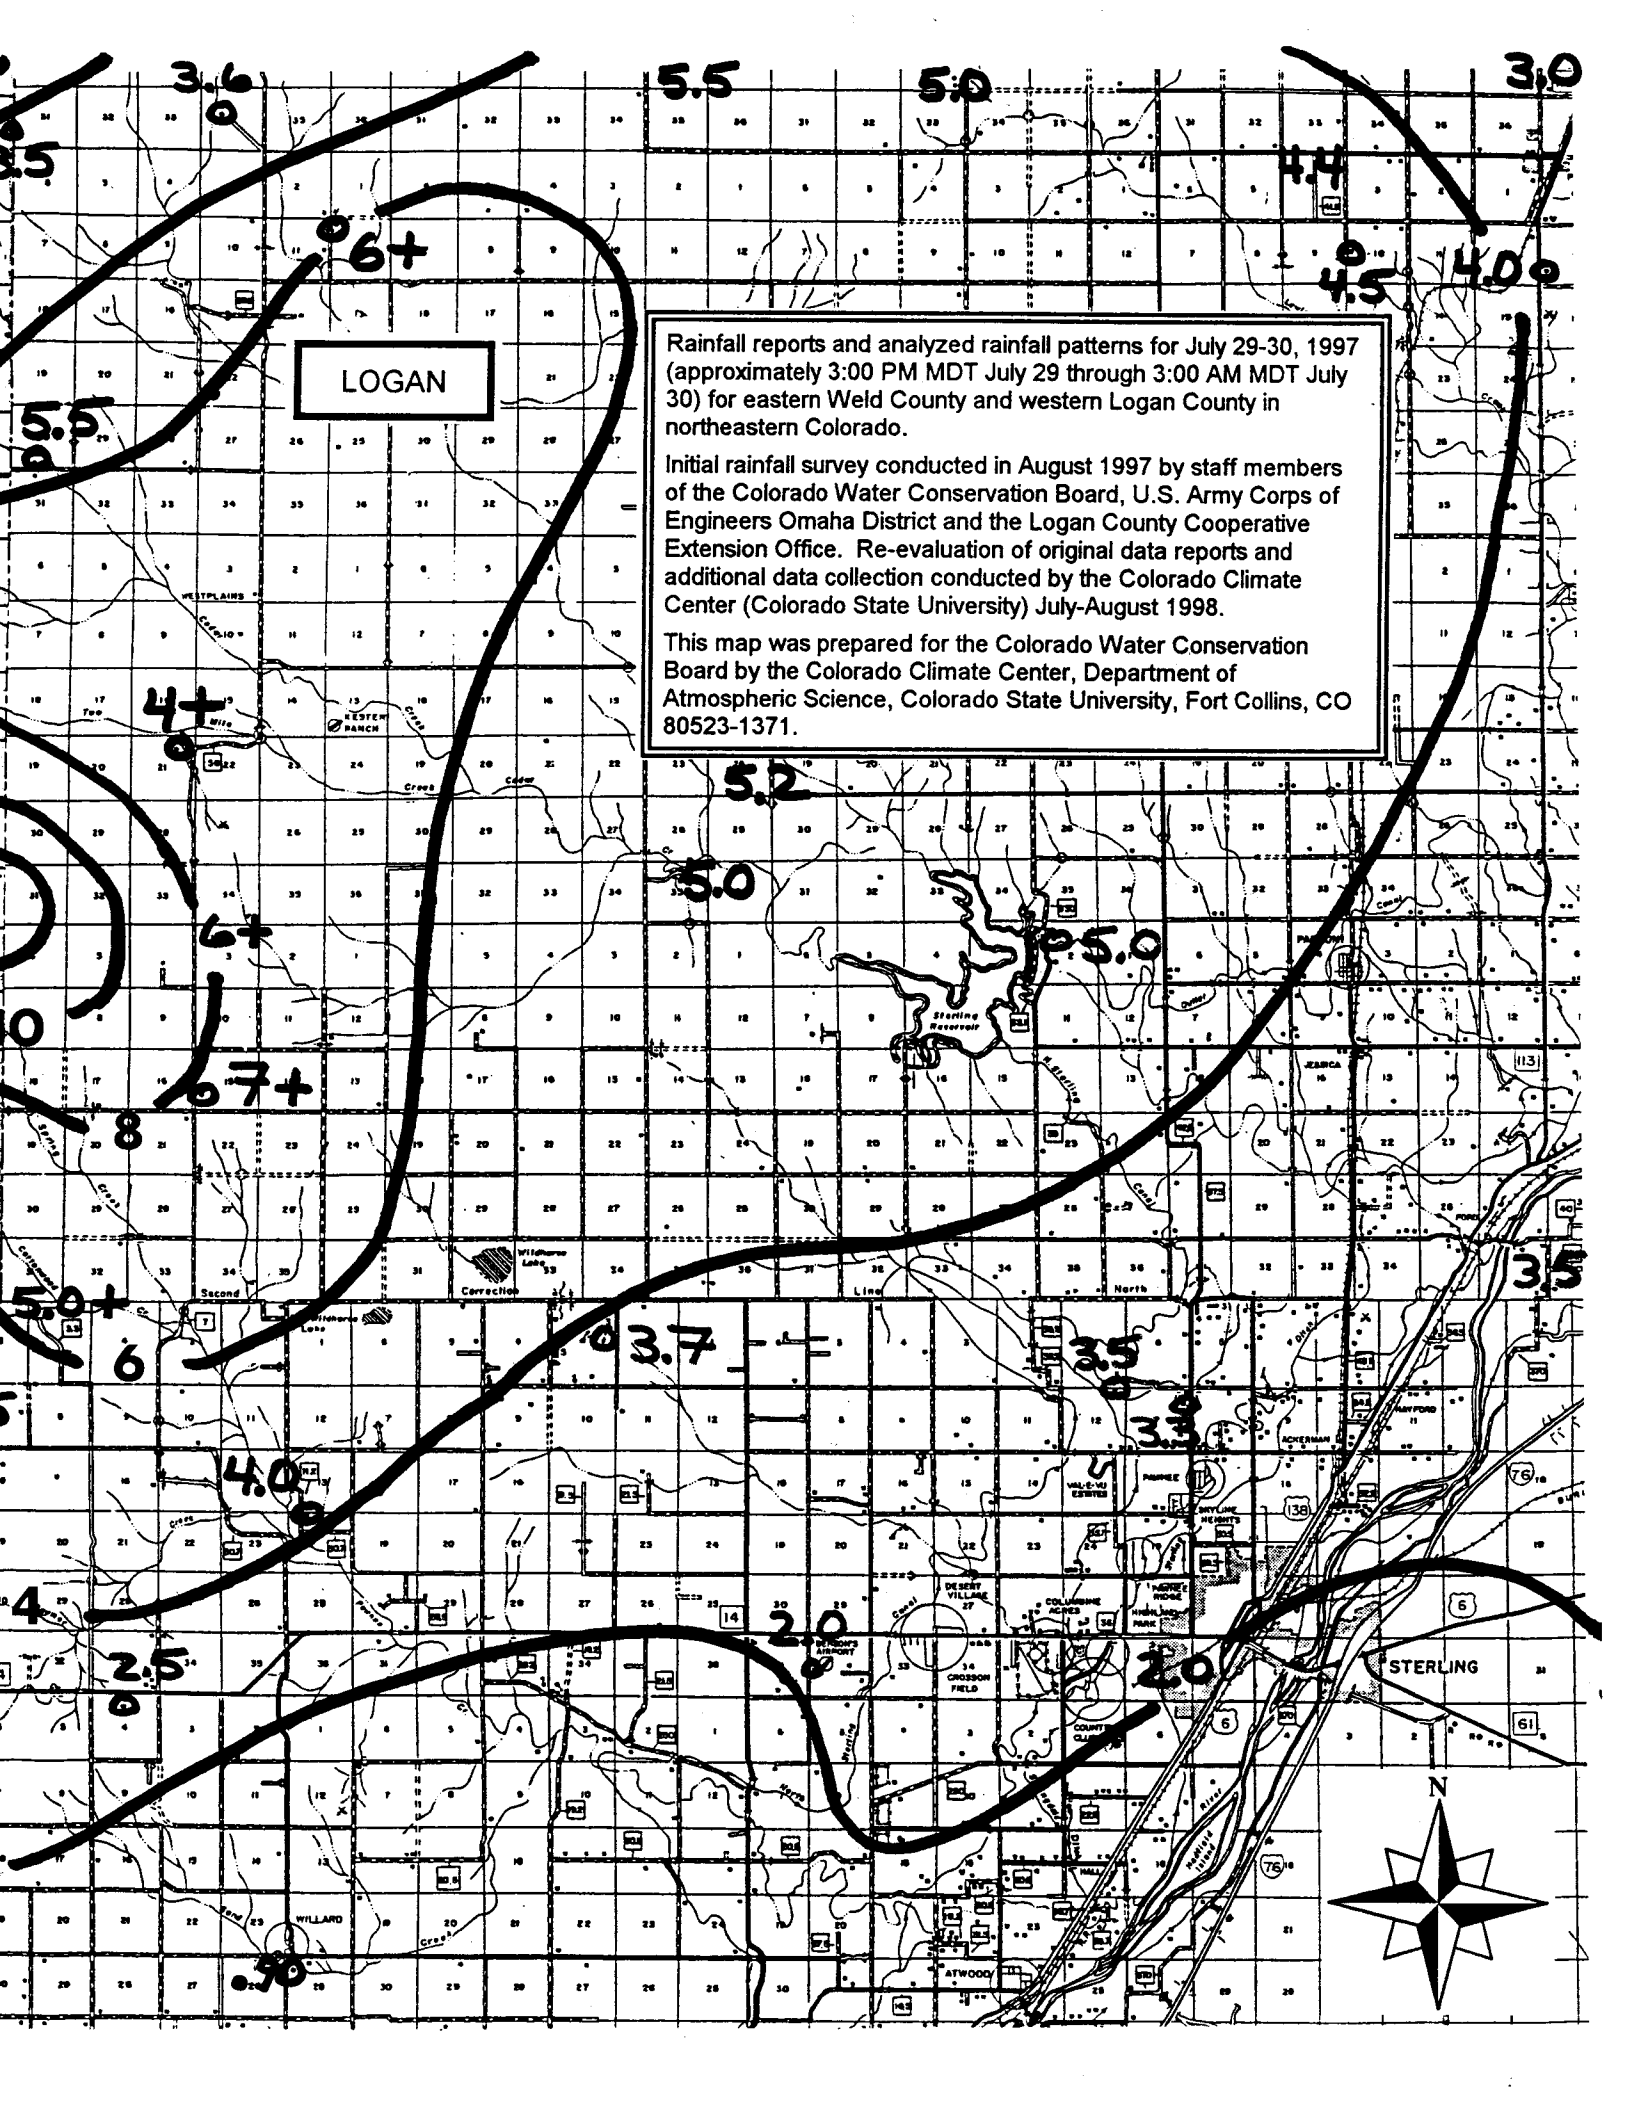
Rainfall reports and analyzed rainfall patterns for July 29-30, 1997 (approximately 3:00 PM MDT July 29 through 3:00 AM MDT July 30) for eastern Weld County and western Logan County in northeastern Colorado.
